# NATIONAL BUREAU OF STANDARDS REPORT

METALLURGICAL EXAMINATION AND MECHANICAL TESTS OF  
MATERIAL FROM THE POINT PLEASANT, W. VA. BRIDGE

Part 5

Bureau of Public Roads  
Federal Highway Administration  
Department of Transportation

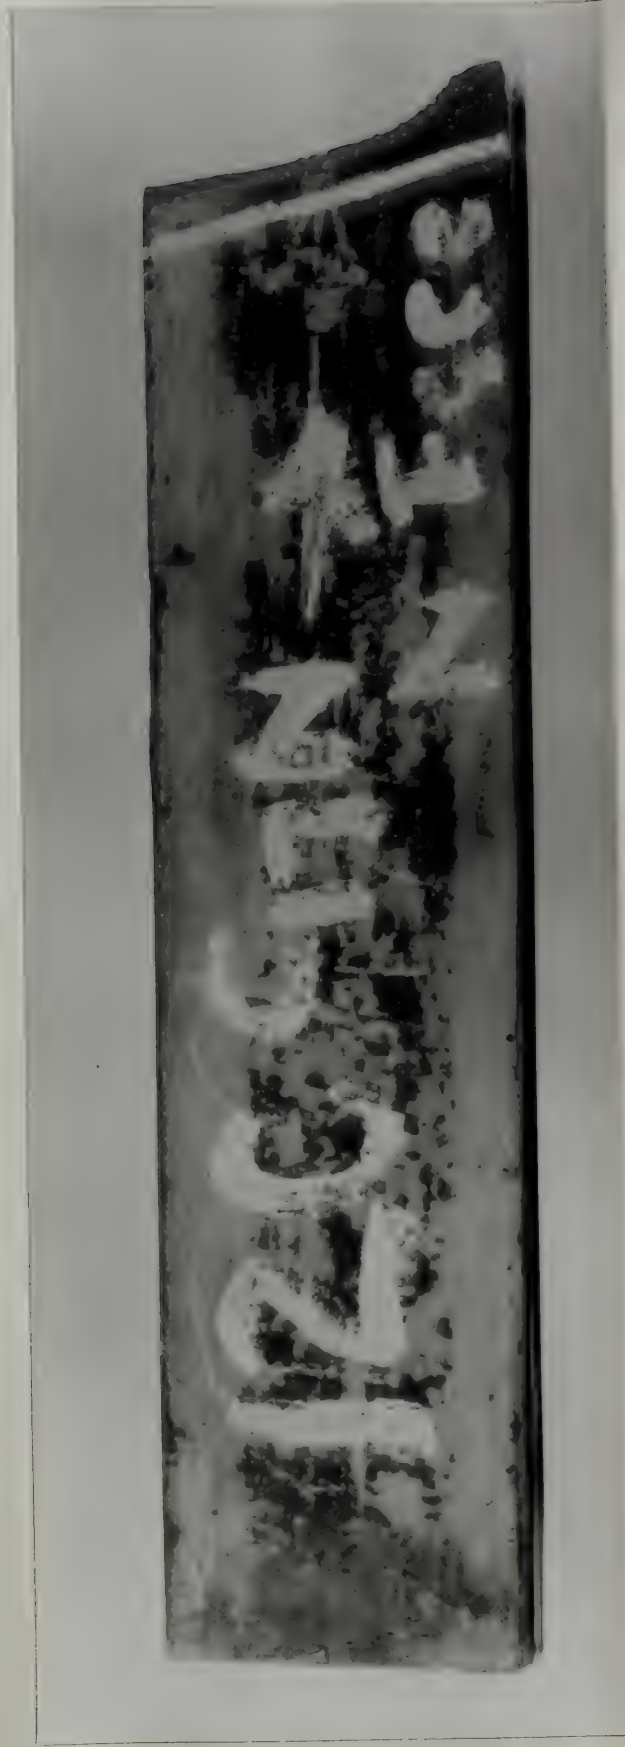
Material: Fragment No. 12C (Bridge Member C<sub>17</sub>-U<sub>17</sub>N), shown in Figure 1, was approximately 1 1/4 in. X 6 in. X 24 in., as received. It was quite rusted on all surfaces. There were, however, vestiges of an orange colored paint and of an aluminum paint on the sides of the piece. All specimens for mechanical tests were removed from the fragment in a section extending from about three inches from the fracture surface to about four inches from the flame-cut end. A section was cut from 12C that contained the fracture surface. It is shown in Figures 2a and 2b.

Figure 1. Hanger fragment 12C (Bridge Member C<sub>17</sub>-U<sub>17</sub>N) as-received.  
Approx. 1/3 x

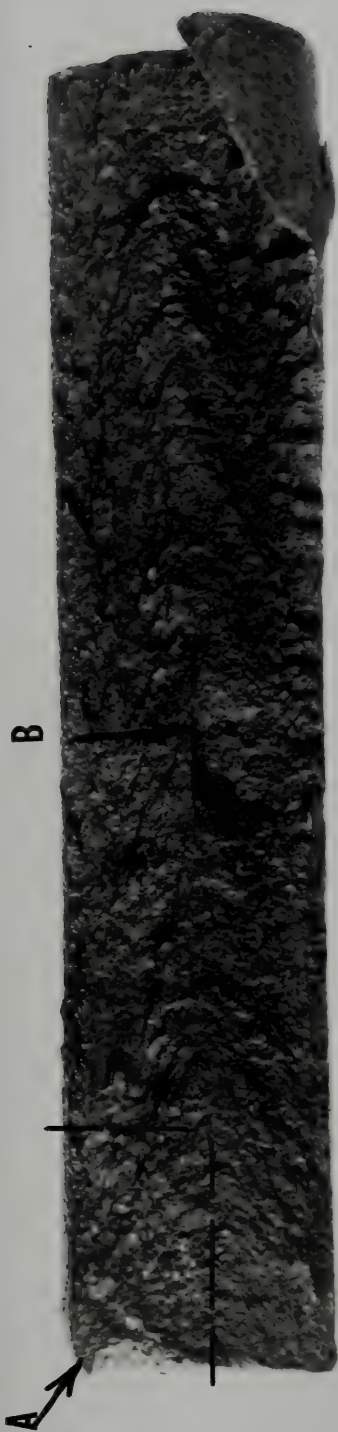
Fracture Examination: Various features in the fracture surface and adjoining areas of the 12C fragment are shown in Figures 2a, 2b, 3a, and 3b. Figure 2a is a head-on view of the fracture surface. The fracture origin is within the boxed area. Orange colored paint was visible on the fracture surface in this area. Arrow, A, points to the battered south-west corner of 12C adjacent to the fracture origin. Arrow, B, points to a secondary crack observed in the fracture surface. This crack was about one-half inch long on the surface and it penetrated the examination section. Figure 2b contains an oblique view of the fracture surface. Vestiges of lead and aluminum bridge paint adjacent to the fracture are visible as grey and white indications, respectively, to the left of the inscription.

Figure 2. Features observed on fracture surface and adjacent areas of fragment from hanger 12C. Approx. 1 X

- a. Fracture origin is shown within boxed area. Arrow, A, points to battered south-west corner of 12C adjacent to fracture origin. Arrow, B, points to secondary crack.
- b. Oblique view of fracture surface. Vestiges of bridge paint are shown to left of inscription; lead paint appearing grey, aluminum paint, white.

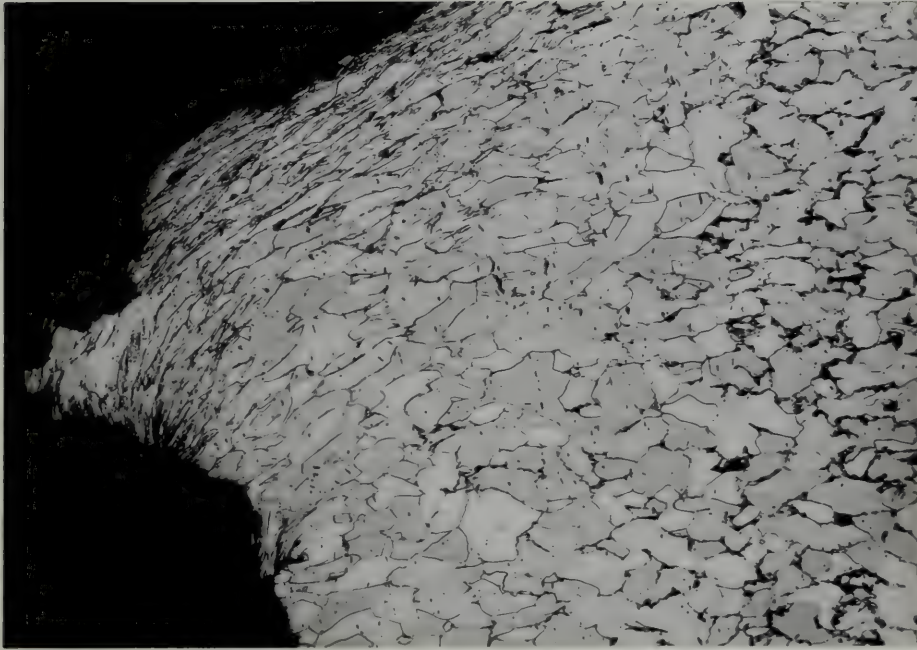
Metallographic Examination: The microstructure of the 12C hanger material was examined at several points along the fracture profile and in areas adjacent to the fracture surface. Decarburization and deformation were observed at the fracture origin, Figure 4a. Continuous cleavage of grains predominated in the section of the fracture profile containing lead, and beyond, (see Figure 4b). Secondary cracks were observed adjacent to the fracture surface approximately one inch from the origin, Figures 5a and 5b. In examination of the structure at mid-section the following were observed:

- a. Decarburization on the side where the fracture originated.
- b. Non-uniform microstructure. A medium-sized grain structure consisting of pearlite in a ferrite matrix in outer areas of the hanger section gave way to coarse grains in a ferrite network in the interior of the section.
- c. A ferrite band extended longitudinally through the middle of the hanger.

Figure 4. Microstructures observed along fracture profile. Etched with 1% Nital. X 100

- a. Deformation and decarburization at fracture origin. Note large grain size.
- b. Continuous cleavage predominated in the section of the fracture profile where lead was deposited.

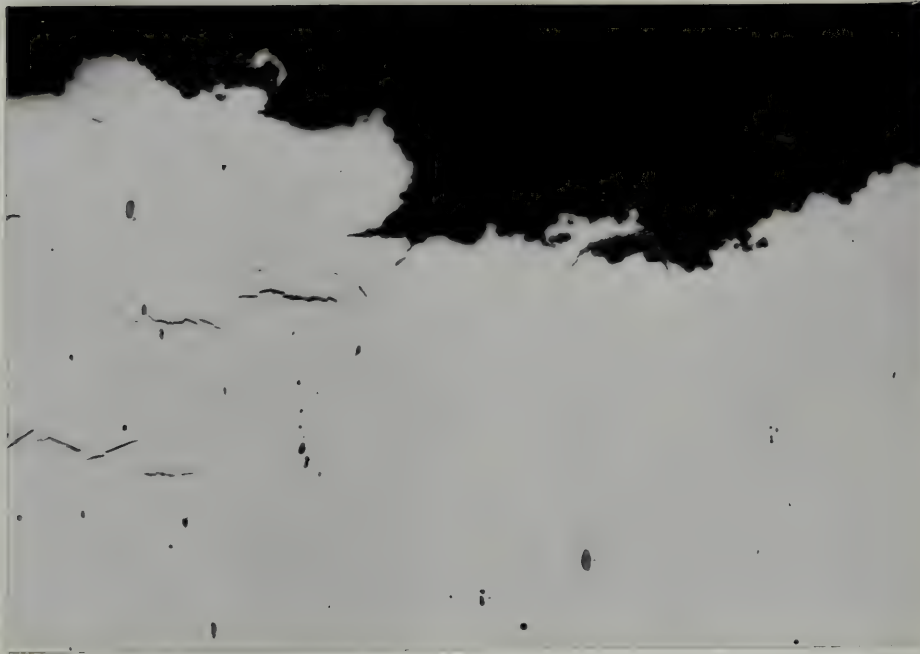
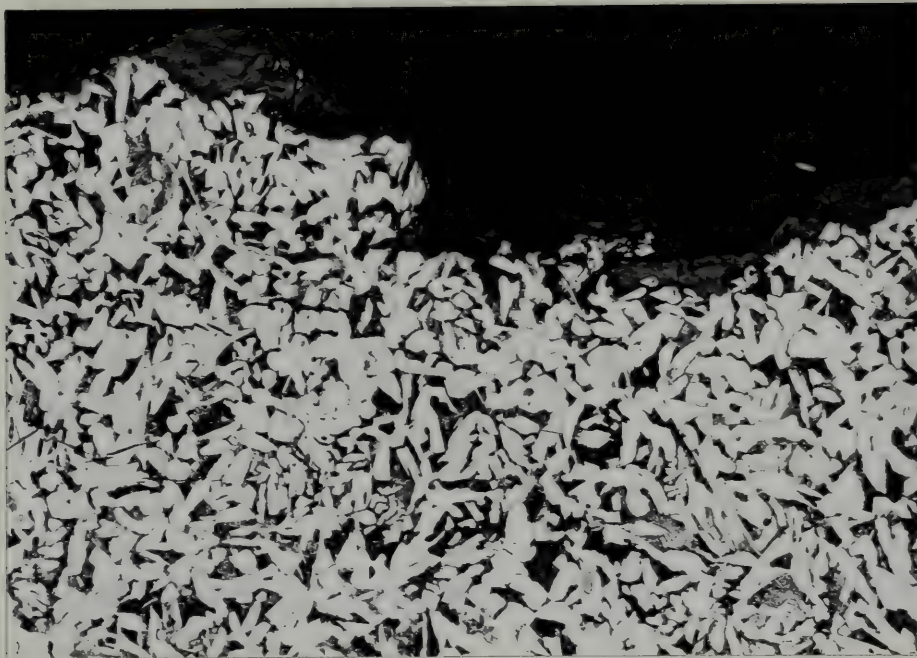
Figure 5. Secondary cracks approximately one inch from fracture origin. X 100

- a. Unetched.
- b. Etched with 1% Nital. Note trans-crystalline nature of secondary cracks.

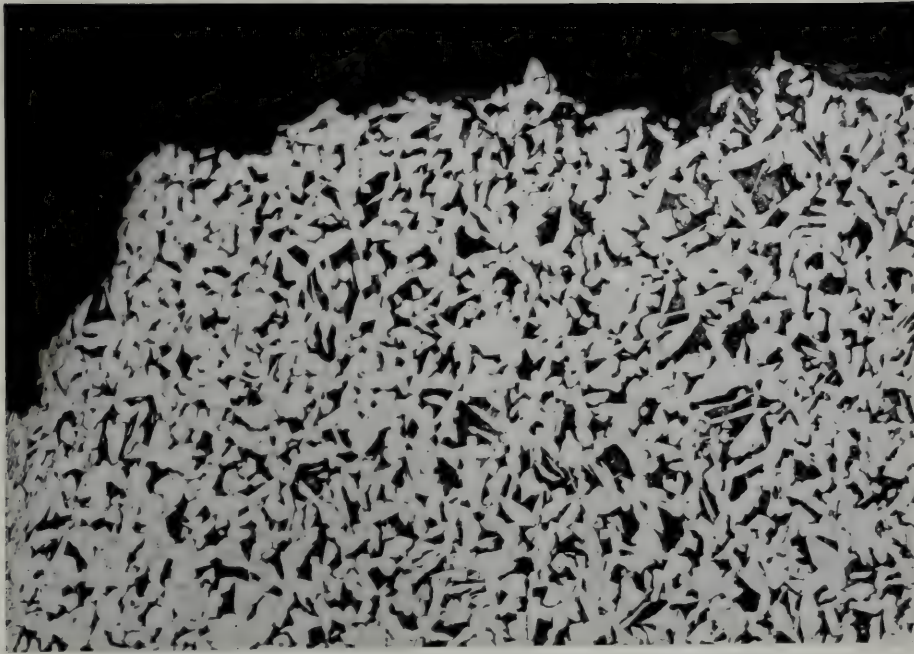
a

Figure 6a. Discontinuous cleavage in fracture profile at mid-section. Etched with 1% Nital. X 80

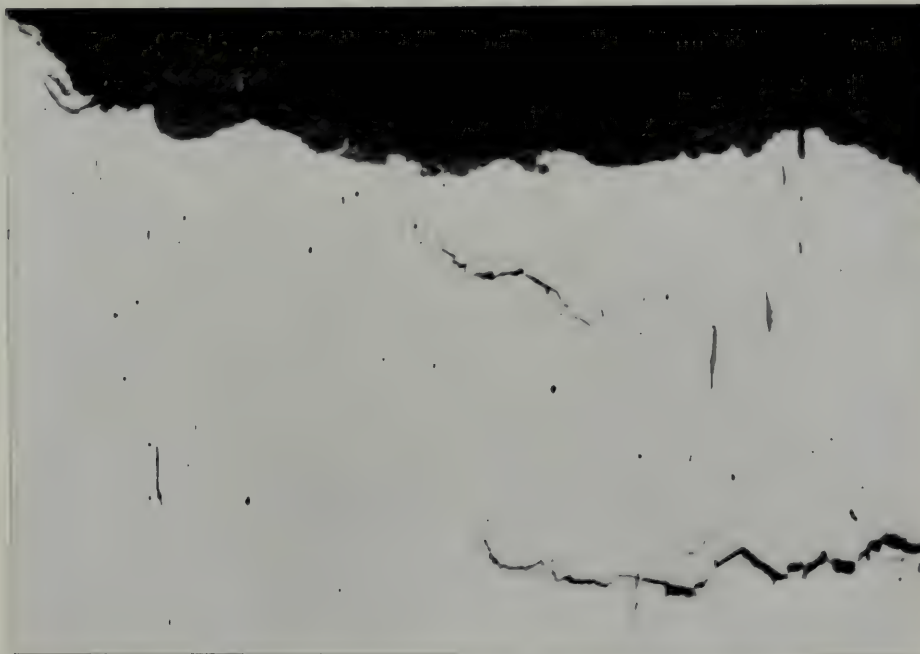
b

Figure 6b. Secondary cracks observed at mid-section. Unetched. X 80

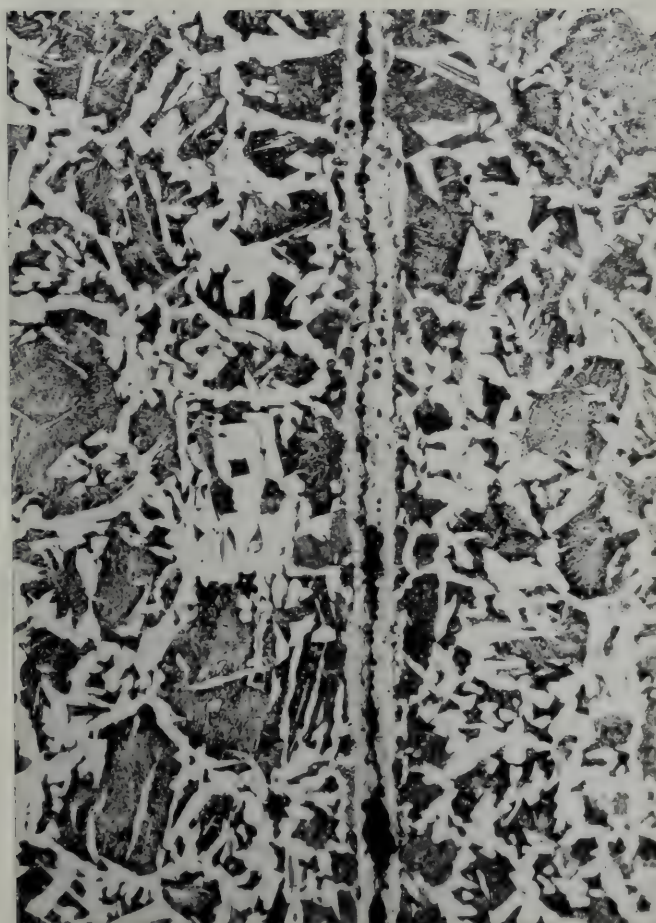
Figure 7. Secondary crack of Figure 2a is shown propagating through a ferrite band. Note large grain size and ferrite grain boundary network (white). Etched with 1% Nital. X 100
